TECHNICAL MEMORANDUM 84/BB

CORROSION PROBLEMS
IN THE CANADIAN MARITIME FORCES

Defence
Research
Establishment
Atlantic

Edited version of an oral presentation given
at the Seventh Inter-Naval Corrosion Conference,
Canberra, Australia, 10 April 1984.

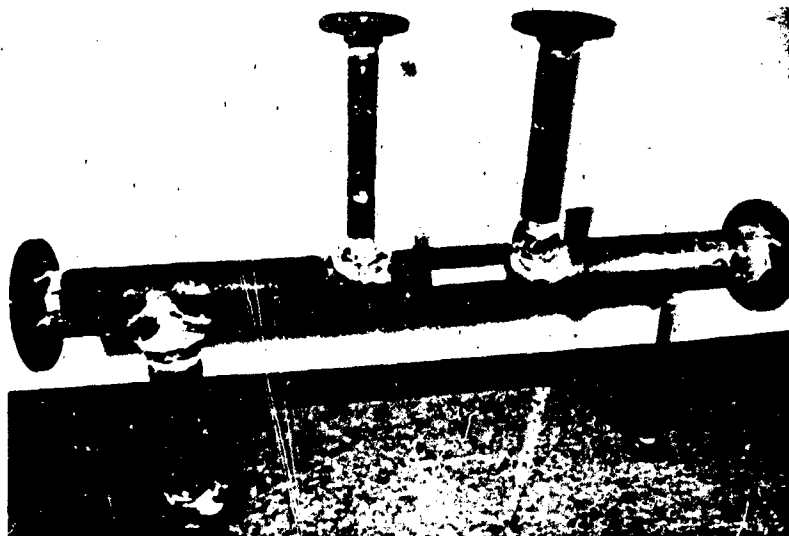
Brazolets are small castings that can be used to make perpendicular connections in firemain systems. Figure 16 shows a mockup of a section of a firemain with varying sizes of brazolets silver brazed to a large 90/10 copper nickel pipe. The brazolet is used in place of a heavier cast tee.

Figure 16 Mockup of firemain system showing leaded tin bronze brazolets and flanges, silver brazed to 90/10 copper nickel pipes.
